Technical Inspection Report  
Bureau of Ordnance Group

OPERATION CROSSROADS.

TESTS 'A' AND 'B'.  
VOLUME III.  
PART I.  
Photographic  
Appendix [u]. 8

Subject: Bureau of Ordnance Material Group Final Report for Tests "A" & "B".

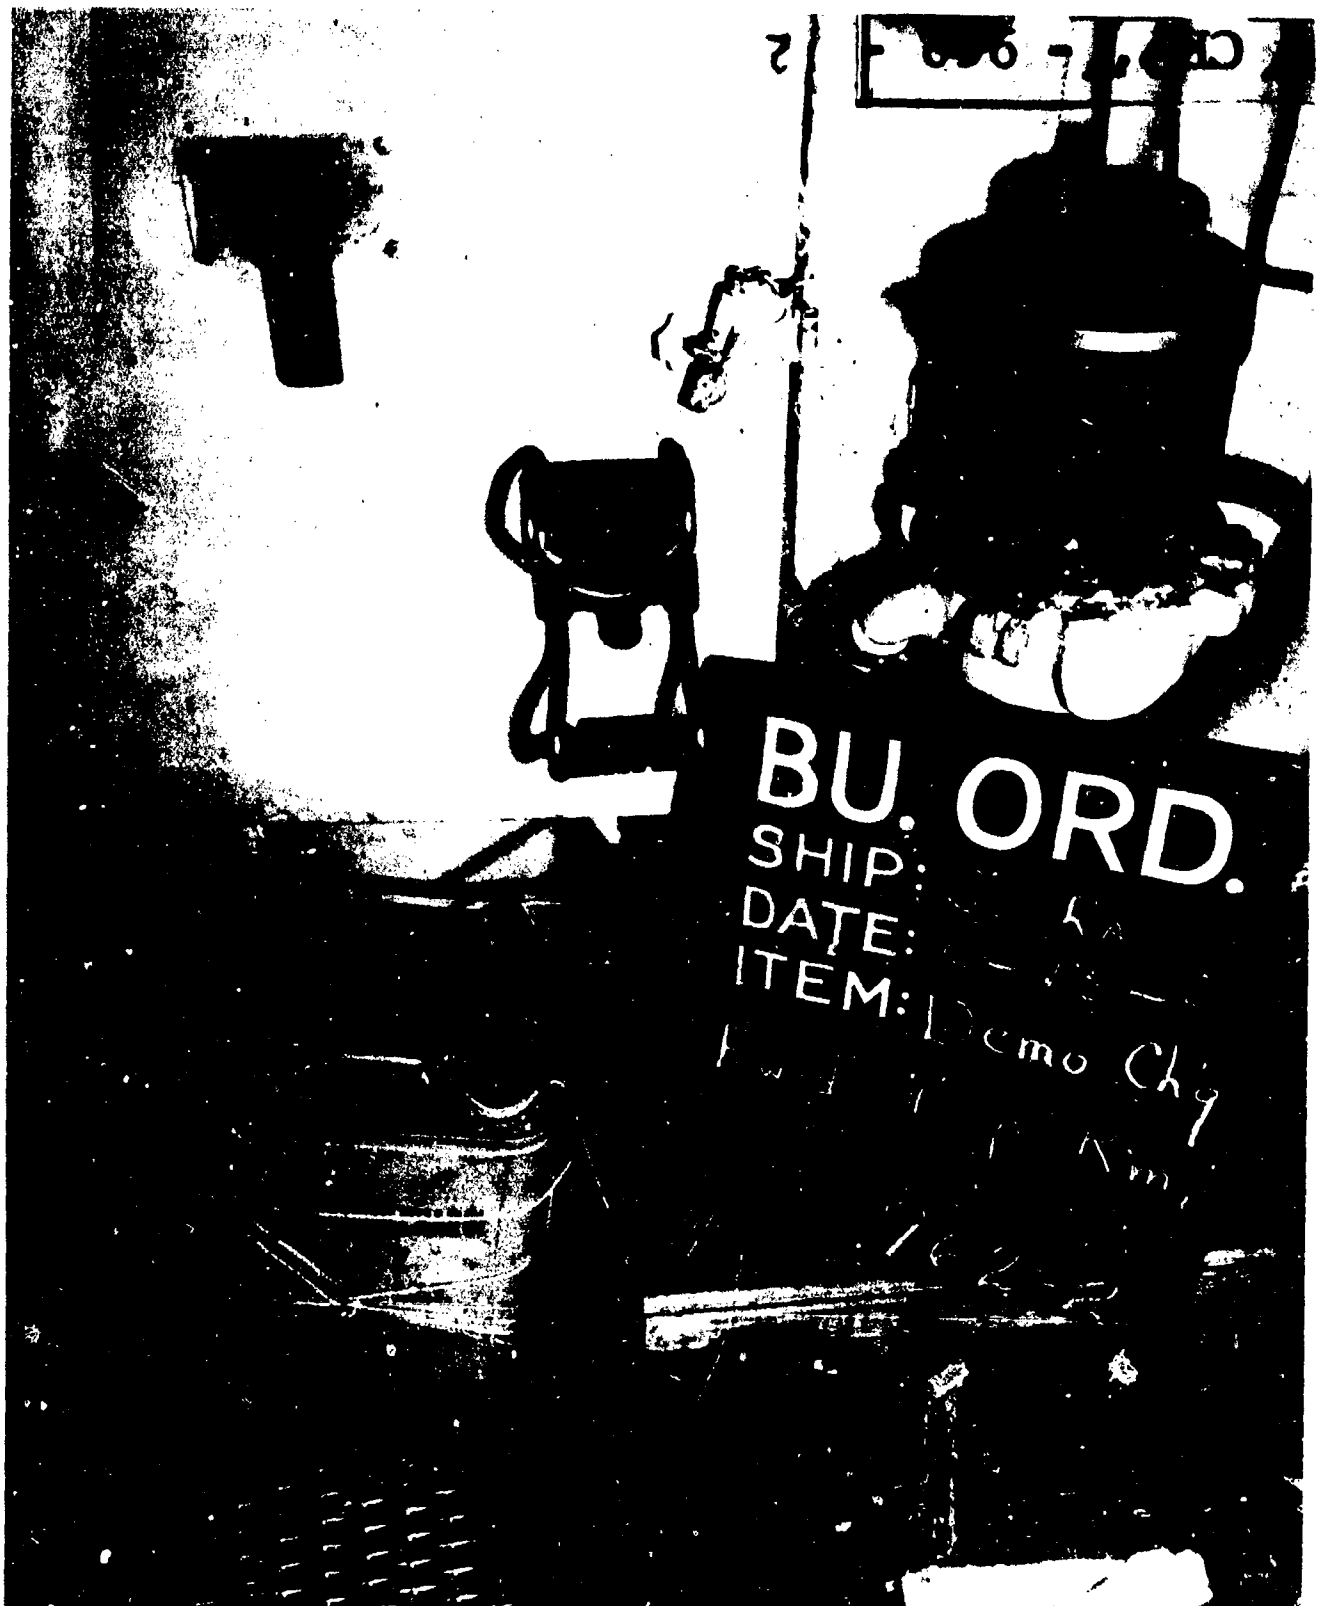
U.S.S. SEARAVEN (SS-196) - Before Able  
Shows the Mk. 2, 55 lb., TNT loaded,  
Demolition Charge in position.  
Photo. No. BA-Ck-97-962-2.

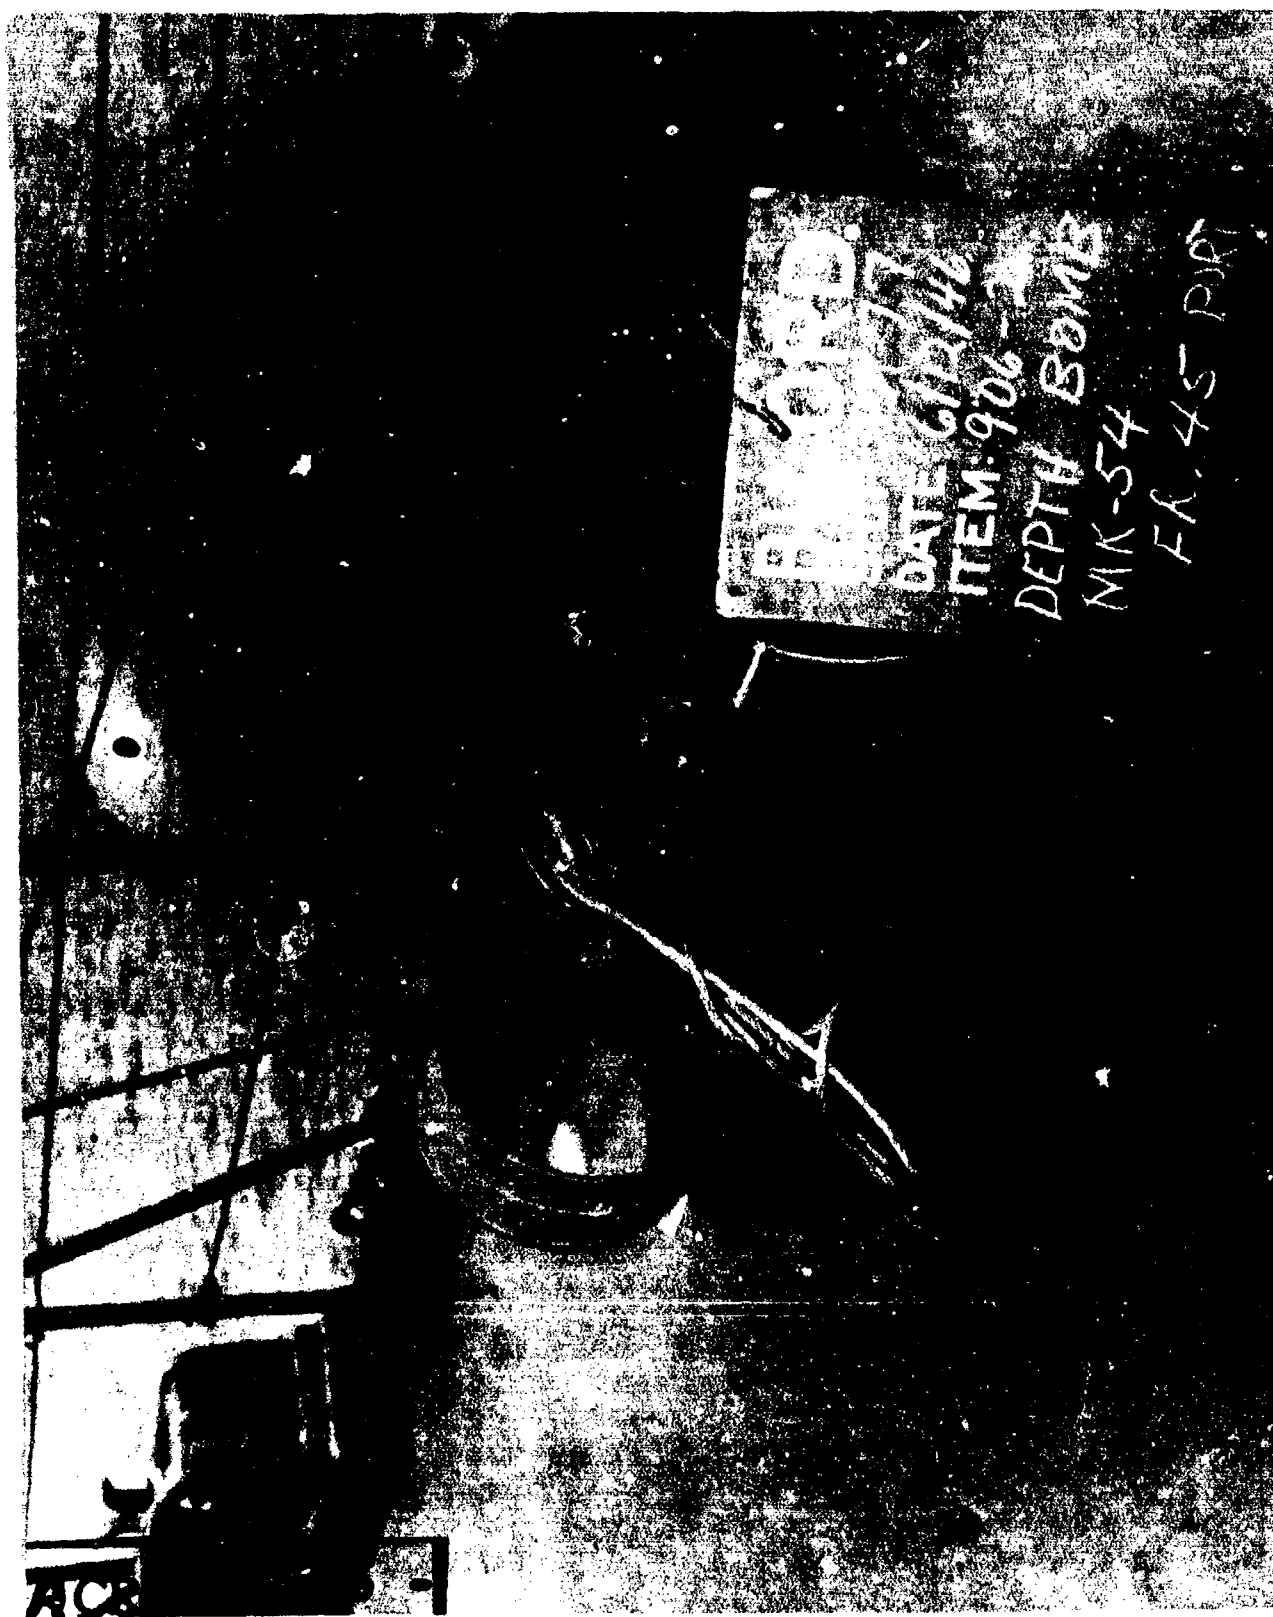
U.S.S. CRITTENDEN (APA-77) - Before Able  
Shows the 350 lb., aerial depth bomb, AN-Mk. 54, Mod. 1, HBX loaded and plugged,  
in position for Test "A". The bomb was located on the 01 deck, frame 45, port side.  
Photo. No. BA-CR-81-906-2.

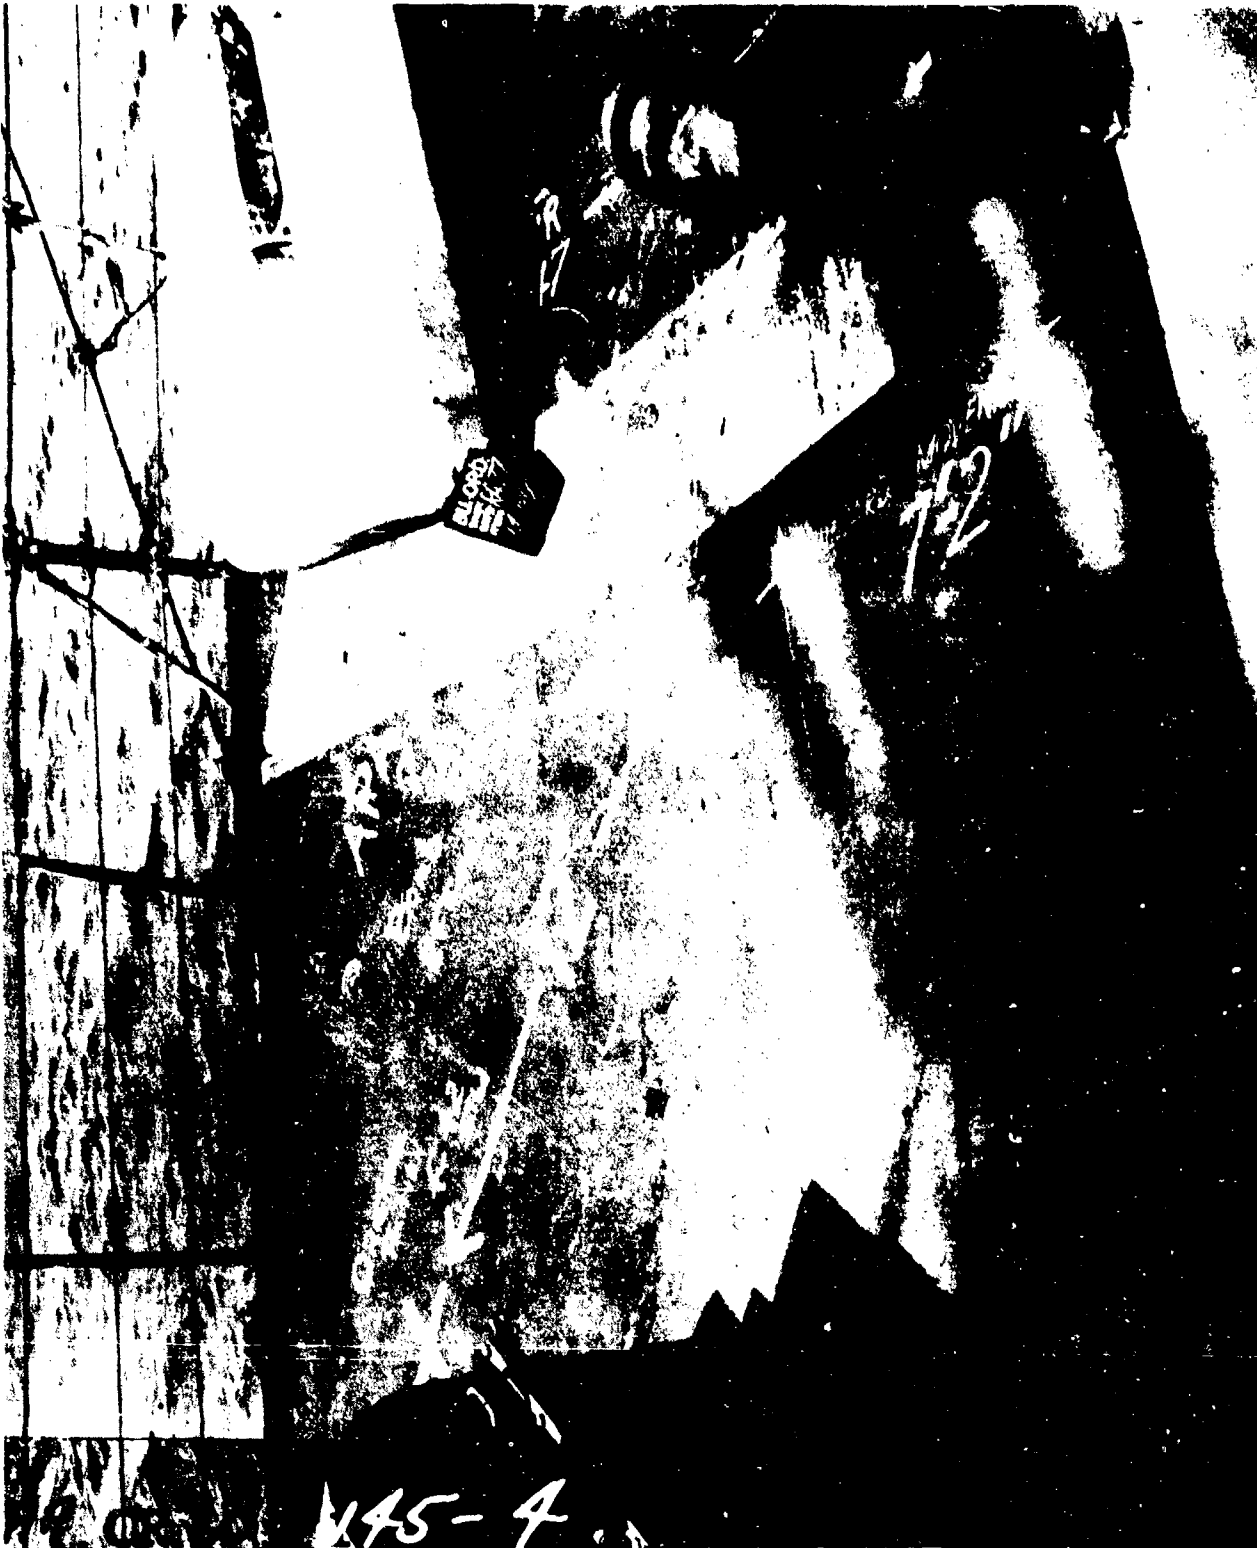
U.S.S. CRITTENDEN (APA-77) - After Able

Shows the final position of the 500 lb., general purpose, aircraft bomb, AN-M64A1, TNT loaded and plugged after it had been blown 12 feet aft and 7.2 feet inboard by the blast. The original position of the bomb was on the 01 deck, frame 42, stbd. side. The Tail Fin Assy. received negligible damage; indications of excessive temperatures were not present.

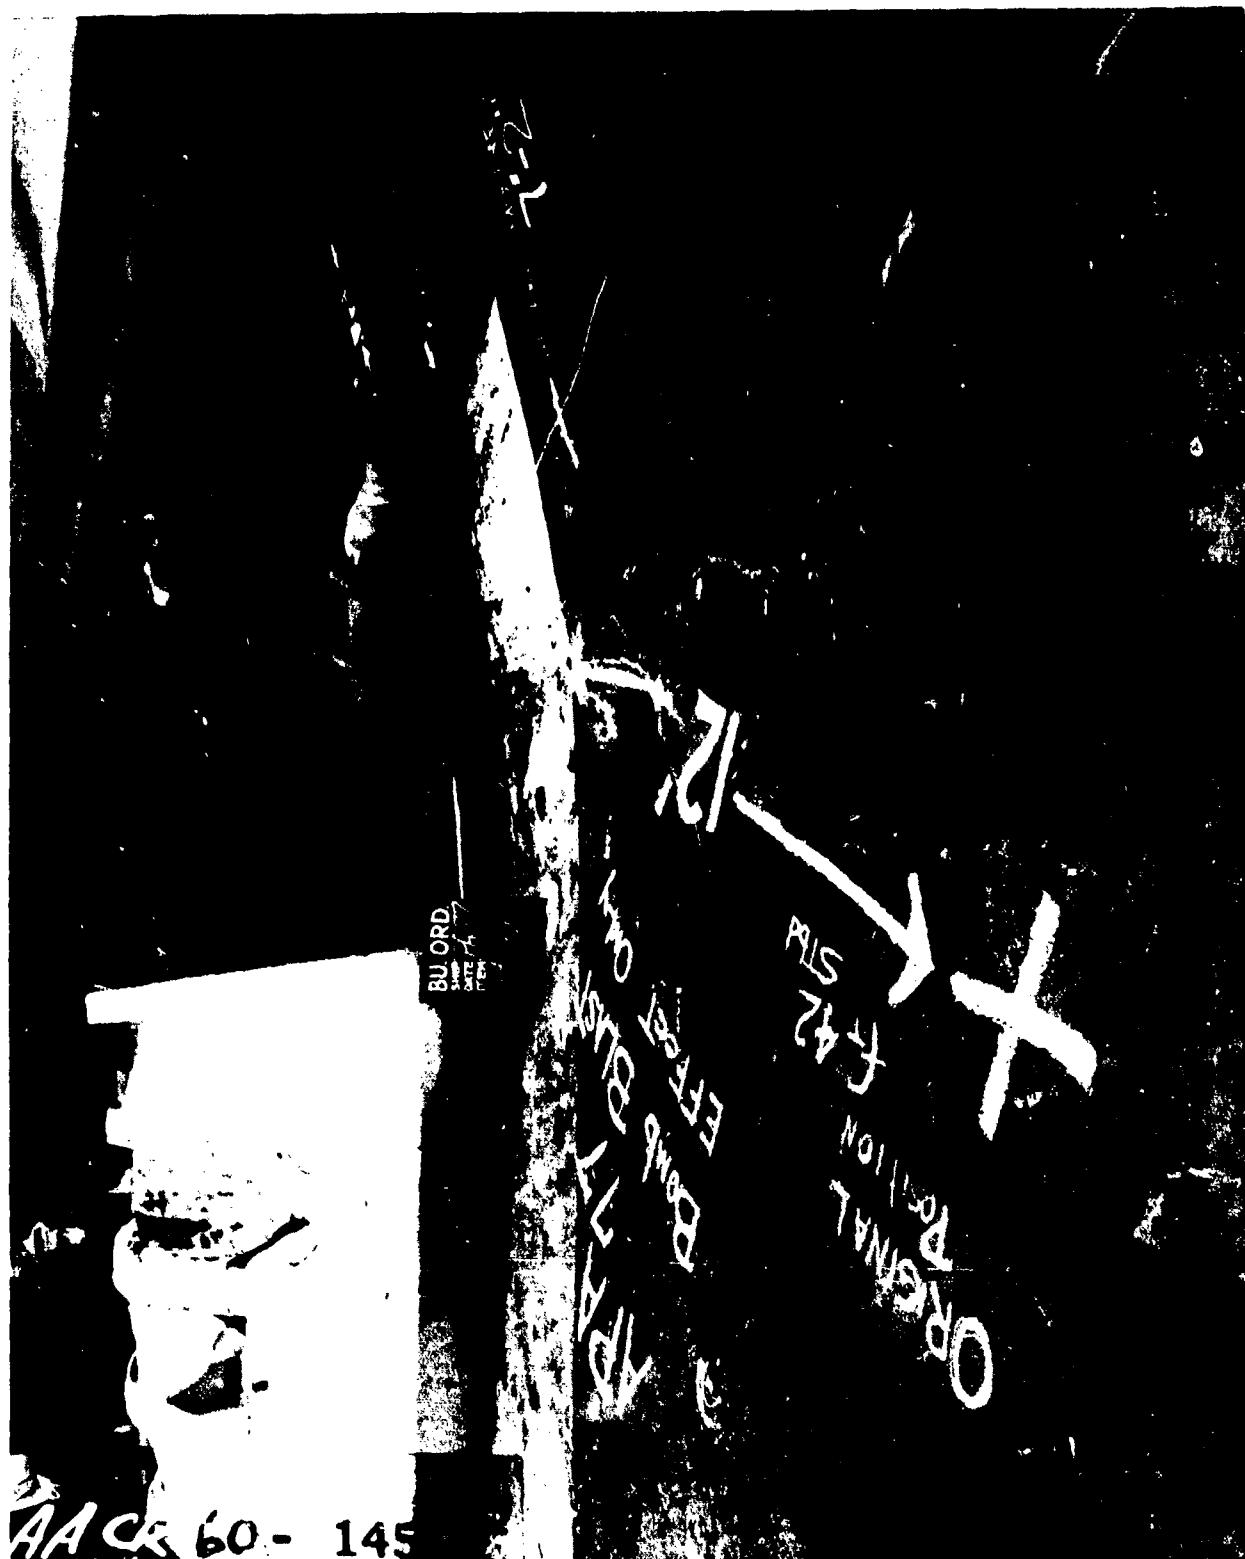
U.S.S. CRITTENDEN (APA-77) - After Able  
 Shows the final position of the 500 lb., general purpose, aircraft bomb, AN-M64A1, TNT loaded and plugged after it had been blown 12 feet aft and 7.2 feet inboard by the blast. The original position of the bomb was on the 01 deck, frame 42, stbd. side. The Tail Fin Assy. received negligible damage; indications of excessive temperatures were not present.  
 Photo. No. AA-CR-60-145-5.

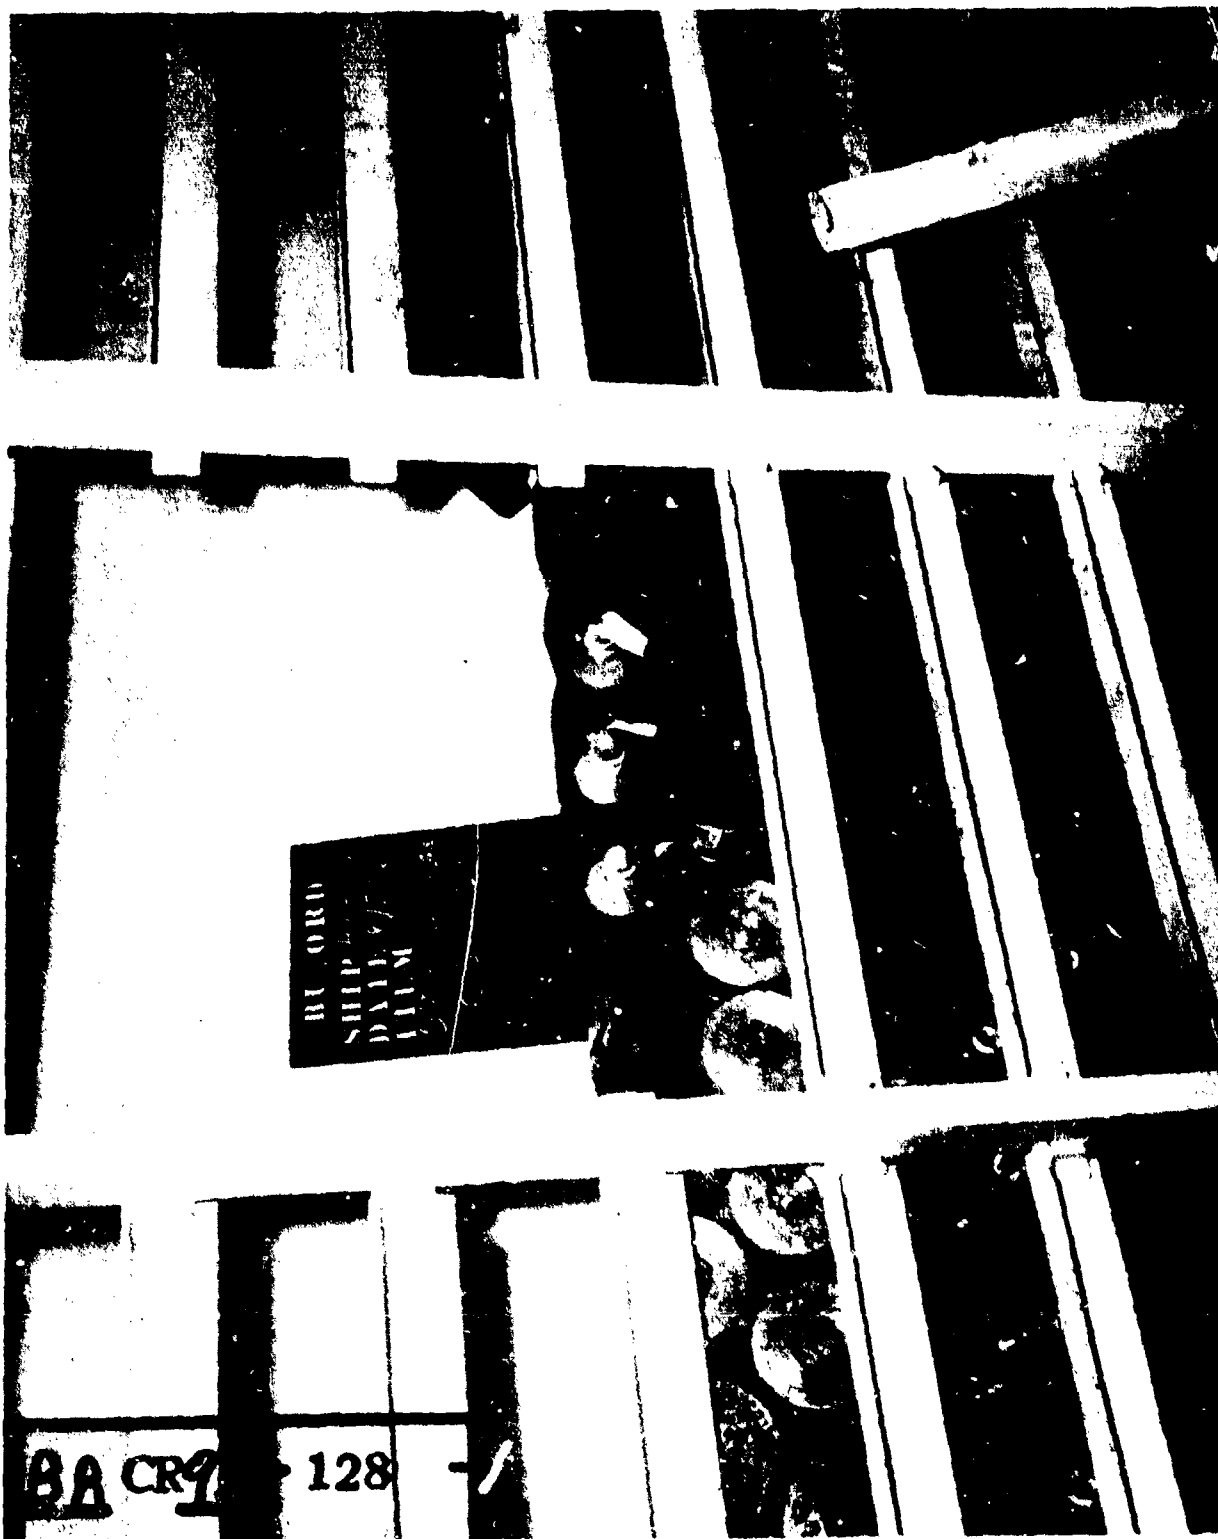
U.S.S. BARROW (APA-61) - Before Able  
Shows the 5".0 Aircraft Rocket Heads,  
plaster loaded and fused, in position prior  
to Test "A". The storage of Rocket Heads as  
shown in this view was employed for all Special  
Test Rocket Heads of this type.  
Photo. No. BA-CR-93-128-1.

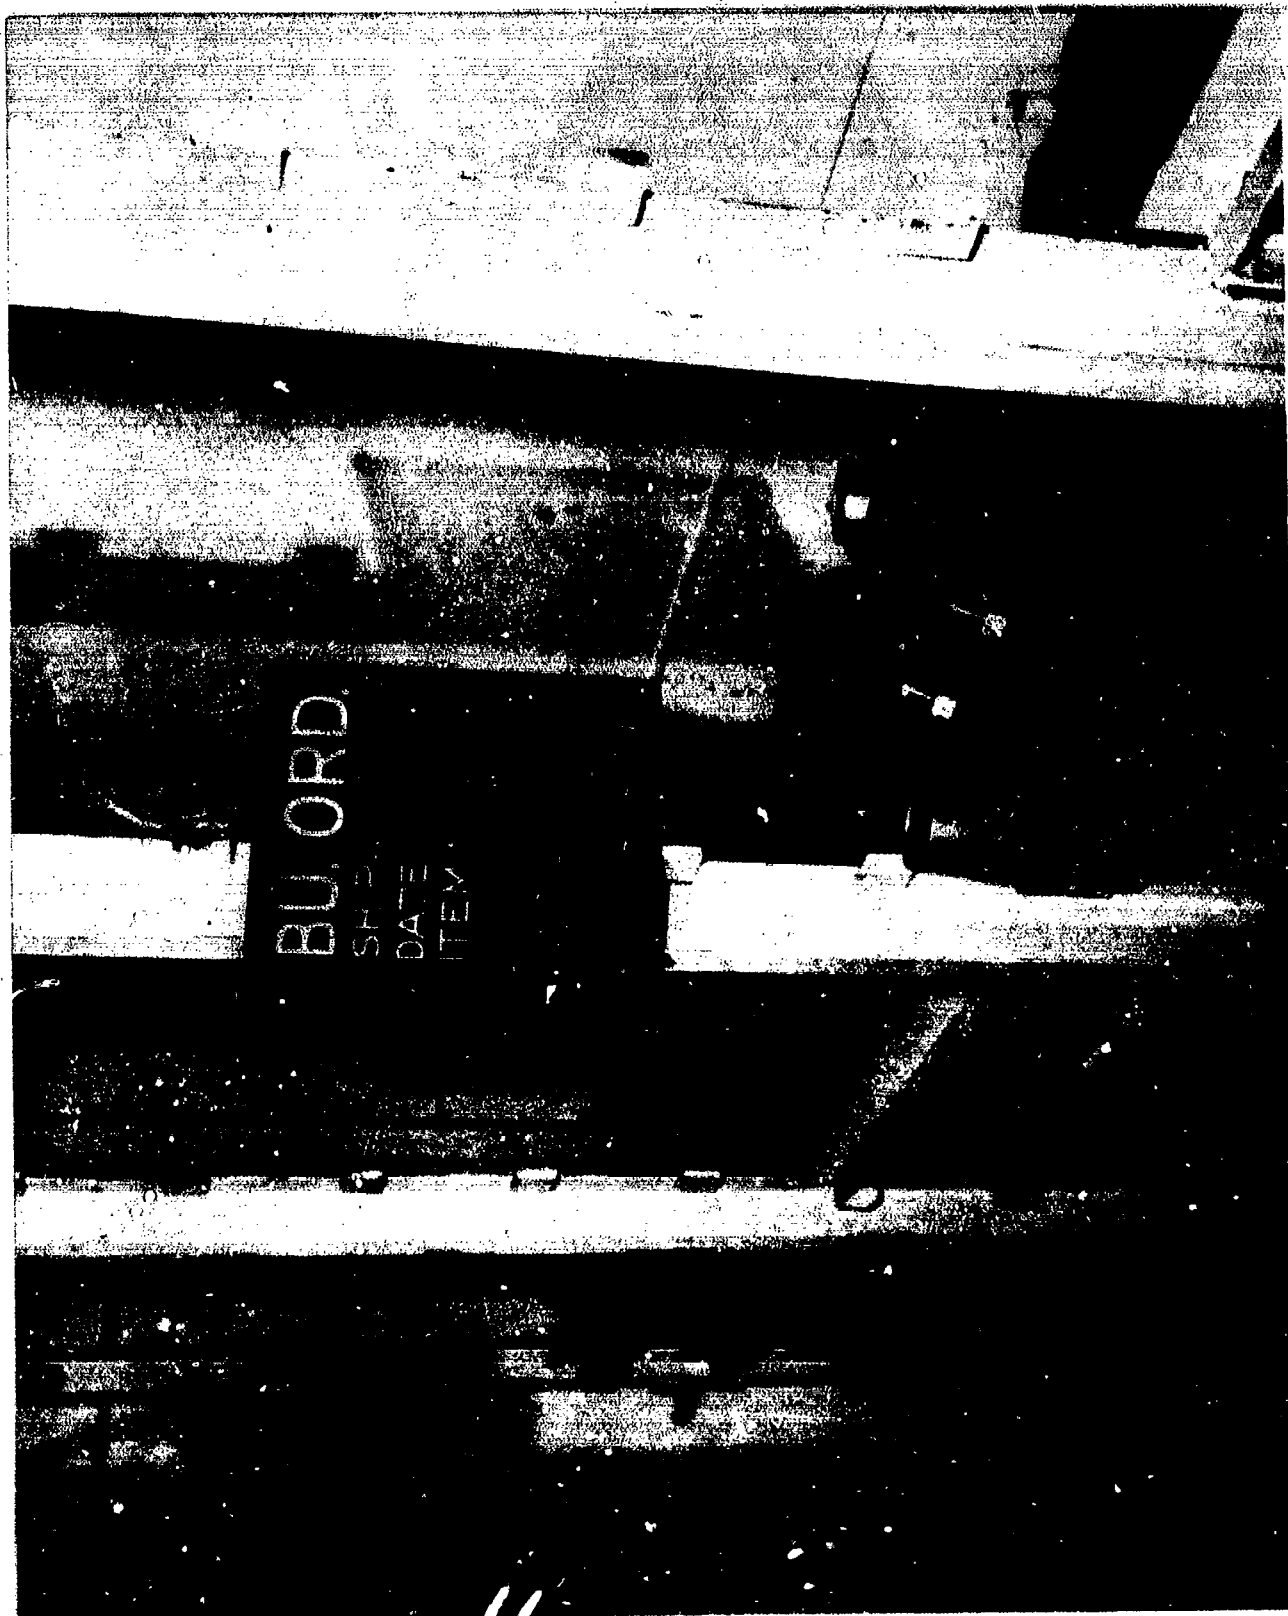
U.S.S. GASCONADE (APA-85) - Before Able  
Shows the 5"/38 projectile storage C-305-M.  
Photo. No. BA-CR-81-432-11.

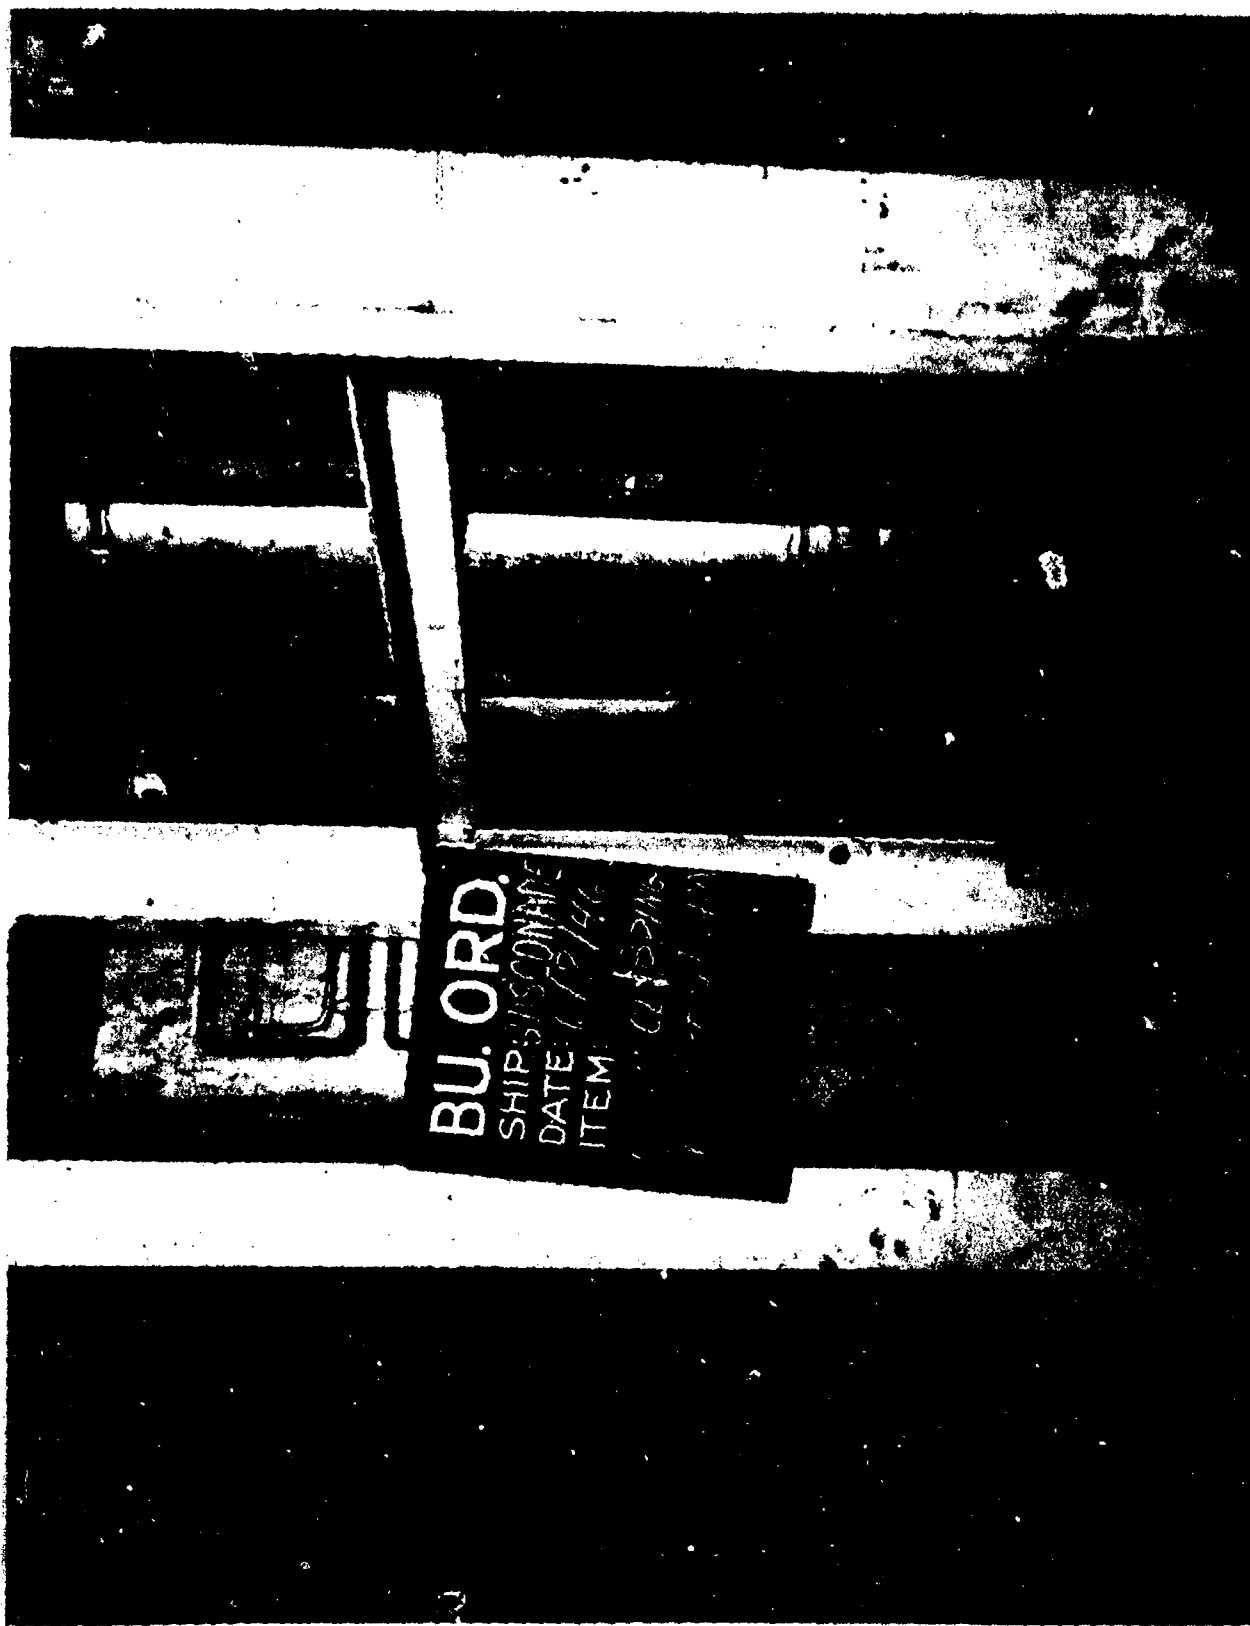
U.S.S. GASCONADE (APA-85) - Before Able  
Shows the 40 MM Clipping Room A-0104-M.  
Photo. No. BA-CR-81-433-3.

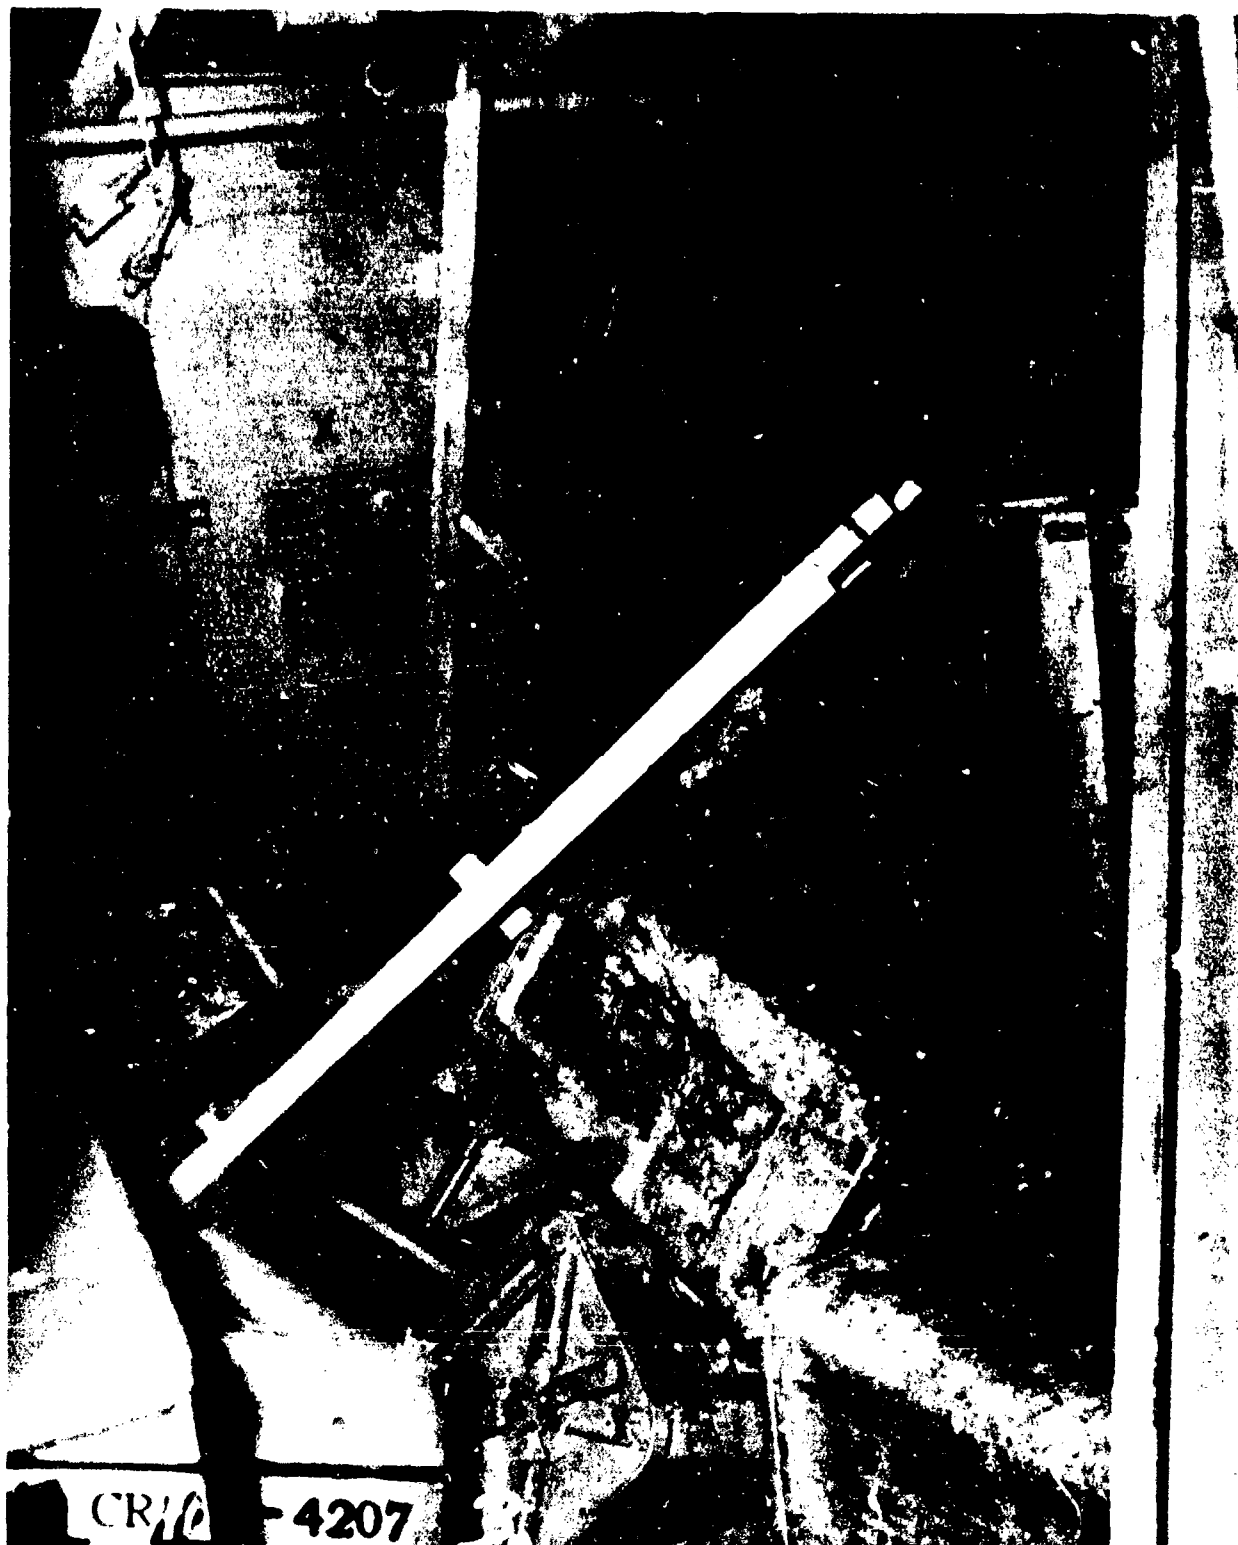
U.S.S. GASCONADE (APA-85) - After Baker  
Shows the effect of shock to the 40 MM  
Ammunition Stowage in the Ready Service  
Room, C-0104-M. The failure of battens  
and stanchions was marked.  
Photo. No. AB-CR-100-4207-3.

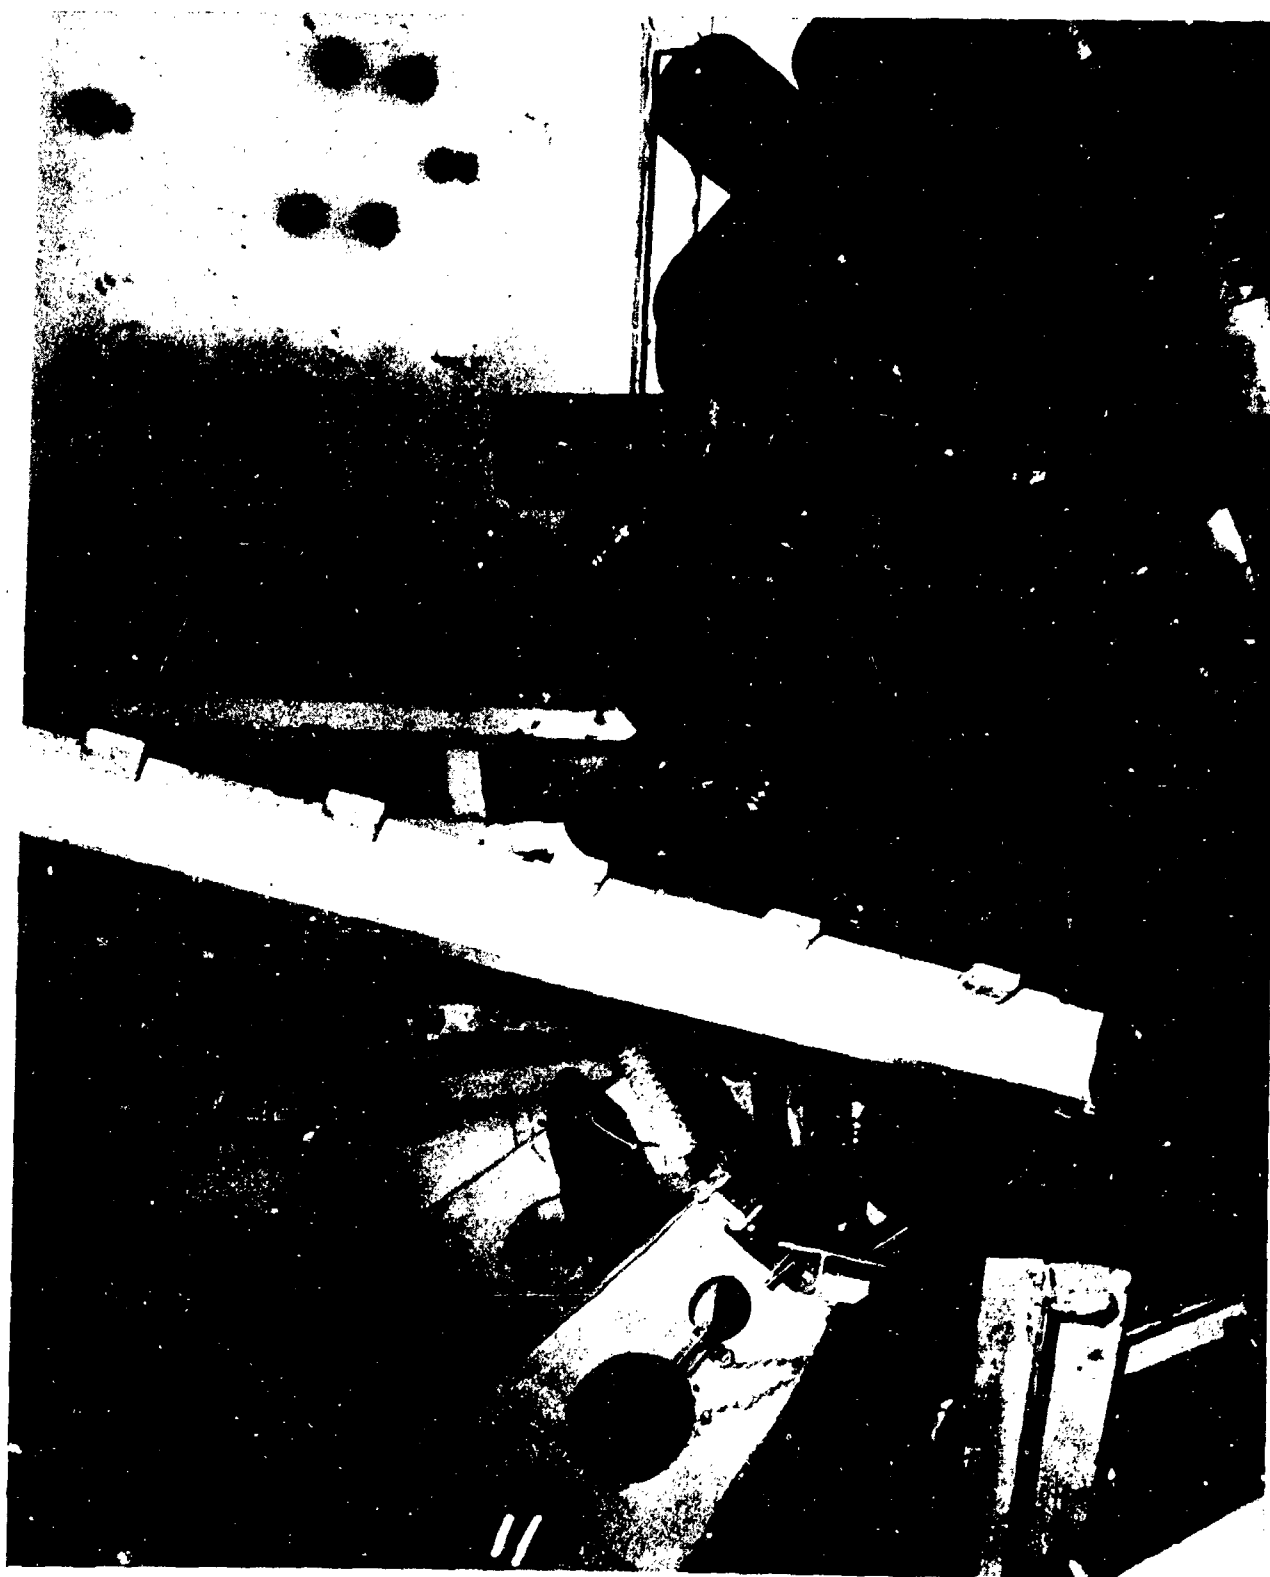
U.S.S. GASCONADE (APA-85) - After Baker  
Shows the effect of shock to the 5"/38  
Projectile Storage in Magazine, C-305-M.  
The failure of battens and stanchions  
was marked.  
Photo. No. AB-CR-100-4210-11.

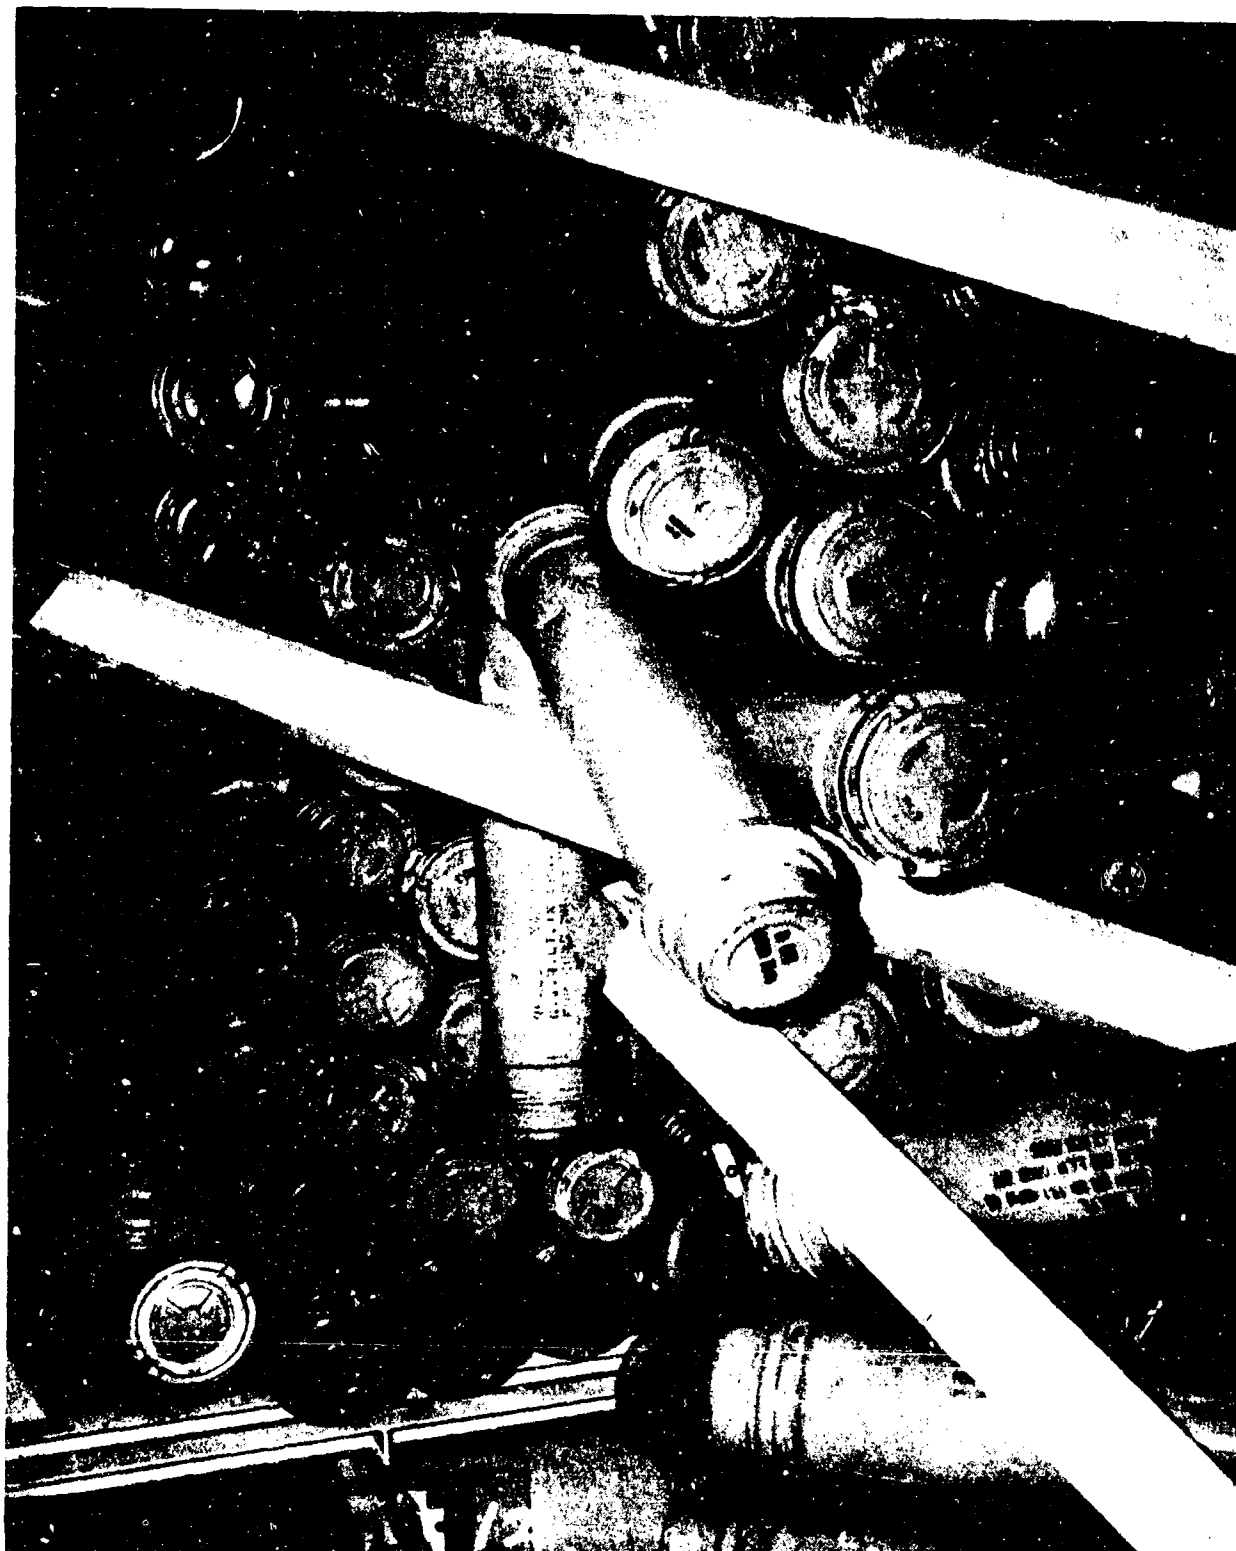
U.S.S. GASCONADE (APA-85) - After Baker  
Shows the effect of shock to the 5"/38  
Powder Stowage in Magazine, C-306-M.  
The failure of battens and stanchions  
was marked.  
Photo. No. AB-CR-100-4210-12.

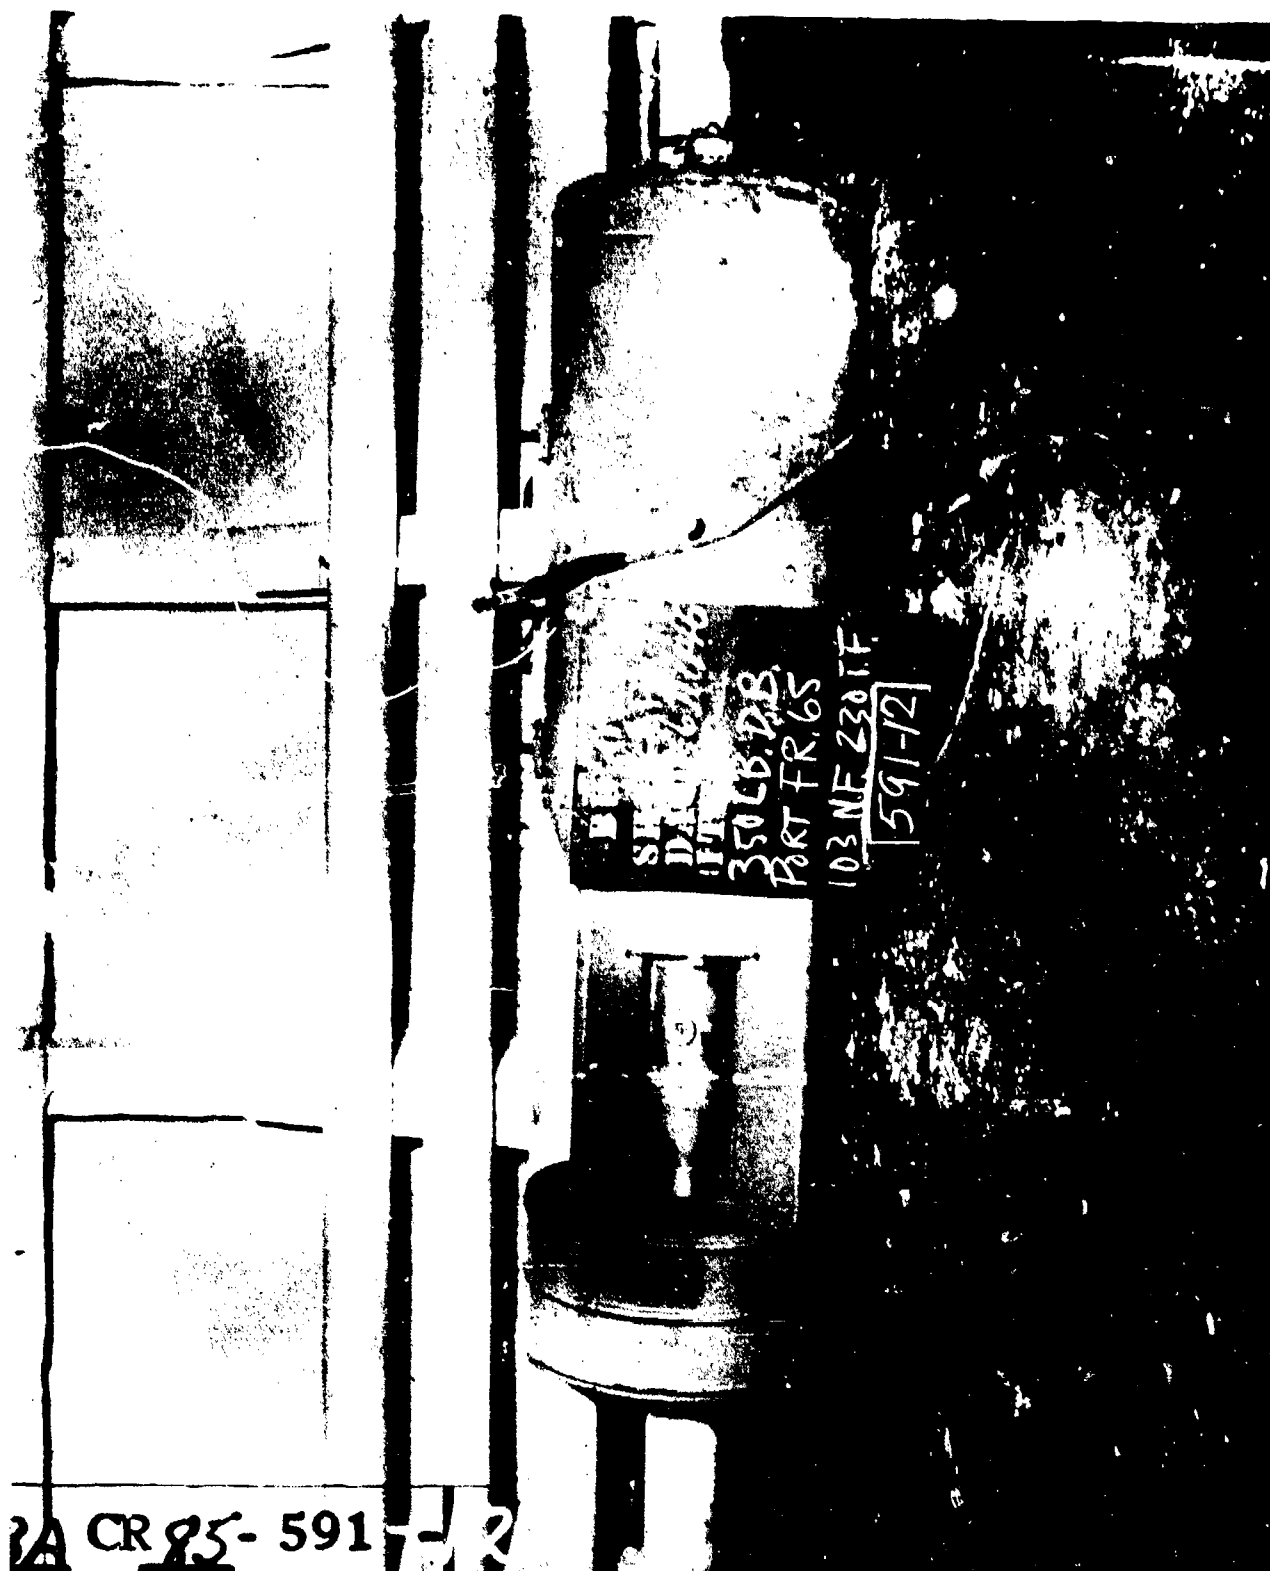
U.S.S. CATRON (APA-71) - Before Able  
Shows the 350 lb., Aerial Depth bomb, AN-Mk. 54, Mod. 1,  
plaster loaded and fused: AN-M103A1 Nose Fuze; AN-Mk. 230-6  
Hydrostatic Tail Fuze, in position prior to Test "A".  
Photo. No. BA-CR-85-591-12.
